Manhole Inspection Summary

Manhole # S1900_017MH

Insp Date: **7/6/07 11:10 AM**

Location Address: **2105 WHITTIER-ELGIN**

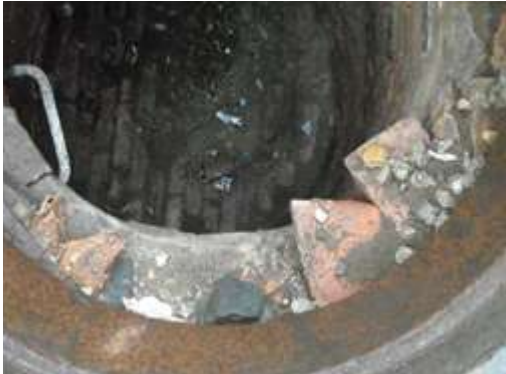
Defect 1

Condition: ☐ Sound ☐ Cracked ☐ Root Intrusion ☒ Loose Brick ☒ Deteriorated

LOOSE BRICKS AND DETERIORATED
FRAME ADJUSTMENT

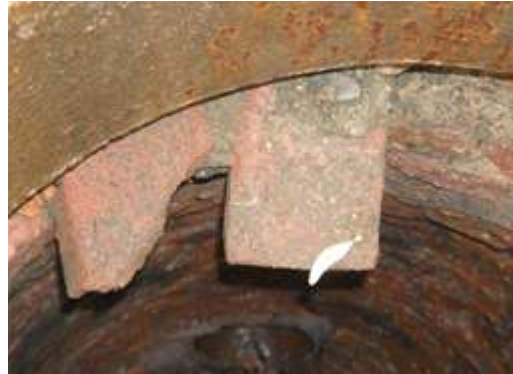
Defect 4

Frame Offset: **4** (in.) Condition: ☒ Sound ☐ Cracked ☐ Leaks

OFFSET FRAME

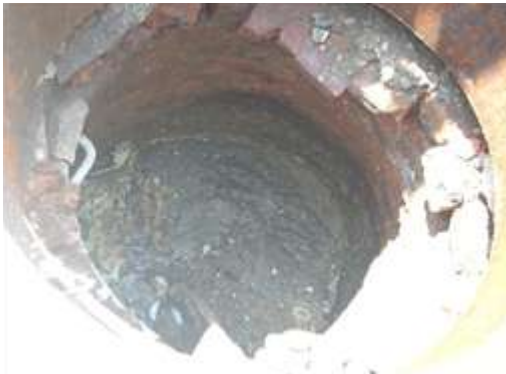
Defect 3

Condition: ☐ Sound ☐ Cracked ☐ Root Intrusion ☒ Loose Brick ☒ Deteriorated

LOOSE BRICKS AND DETERIORATED
COBEL

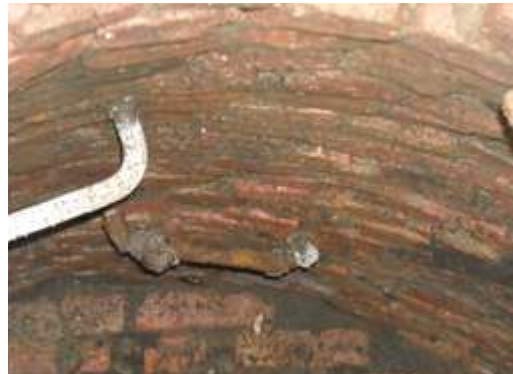
Defect 2

Steps Count: **2** Missing: **0** ☒ Corroded

Surcharge ☒ Evidence Of Surcharge Depth: **2** (ft.) ☐ Active Surcharge Present

CORRODED STEPS AND EVIDENCE
OF SURCHARGE
